# Commercialization of Military & Space Electronics - Conference

## **Commercial Off-The-Shelf (COTS) Program**

**Using Nondestructive Methods (C-SAM) for COTS  
PEMs Screening and Qualification**

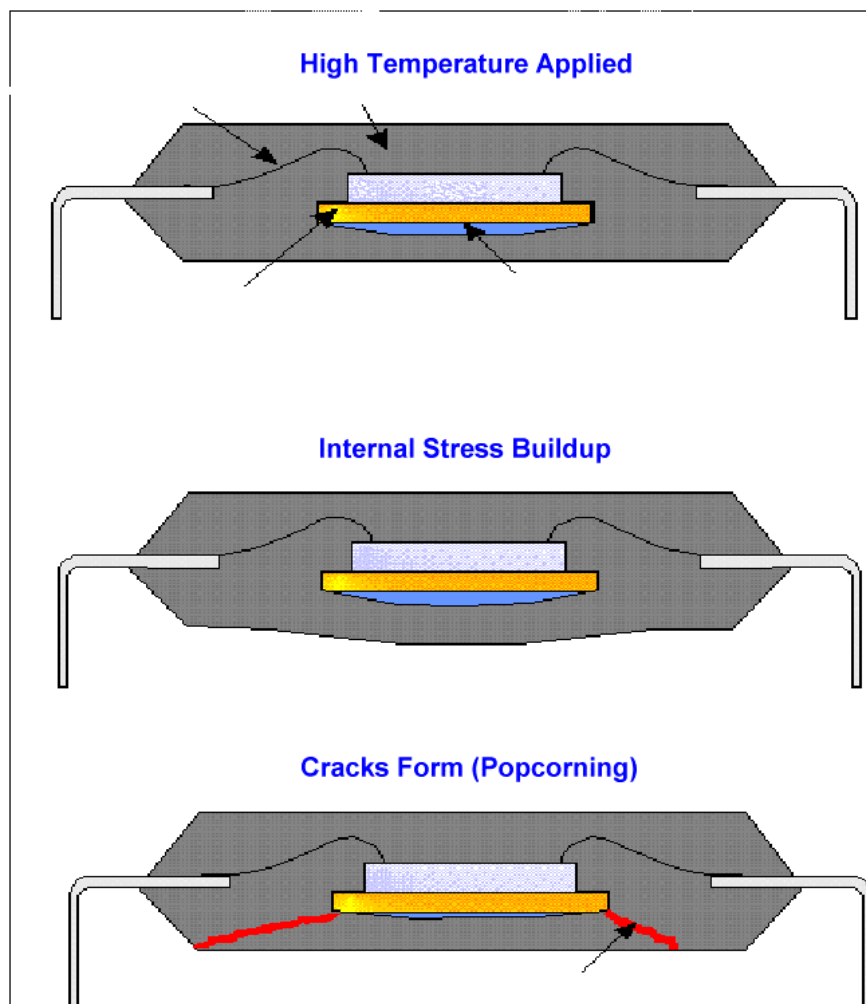
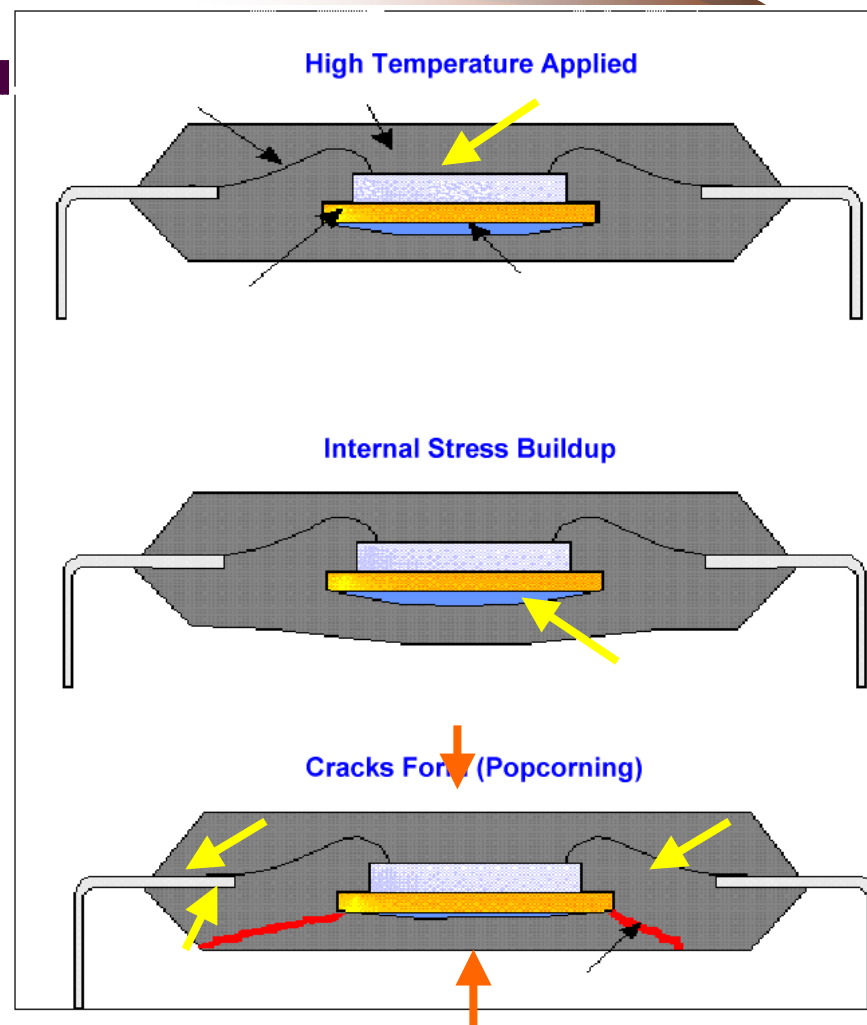
# Popcorning Failure Mechanism from Internal Moisture

## C-SAM Inspection Points for delamination which can accelerate entry of moisture/collection

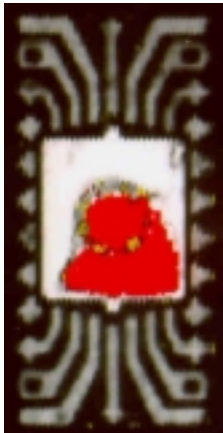
Reject

**C-SAM Rejects (JPL examples):** (Devices with  $>> 10\%$  delamination in critical areas are suspect and are rejected)

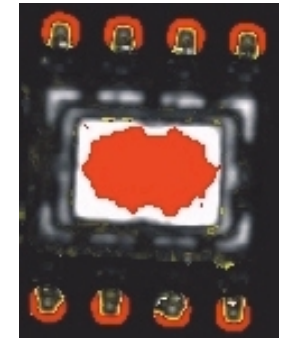
Pass\*

\*Delamination is not evident because of die top coating used by the manufacturer. (e.g. C-SAM limitation)

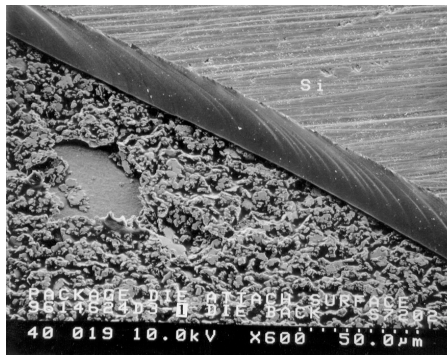
A. Die attach void at  
the heat sink surface

Definitive results were found on six suspect problem areas submitted for analysis.

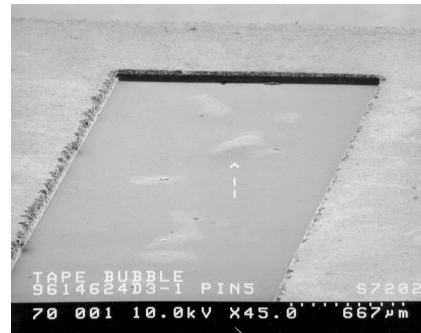
B. Bubble exists from  
Mylar tape near pin 5

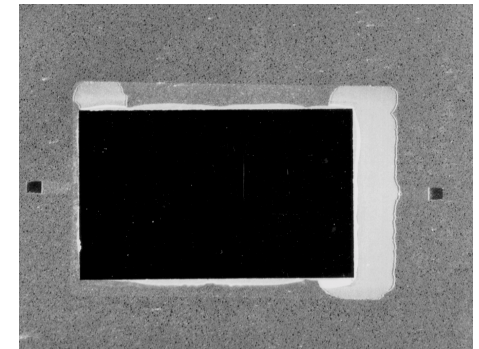
C. Delamination and lack  
of adhesion between  
die and heat sink

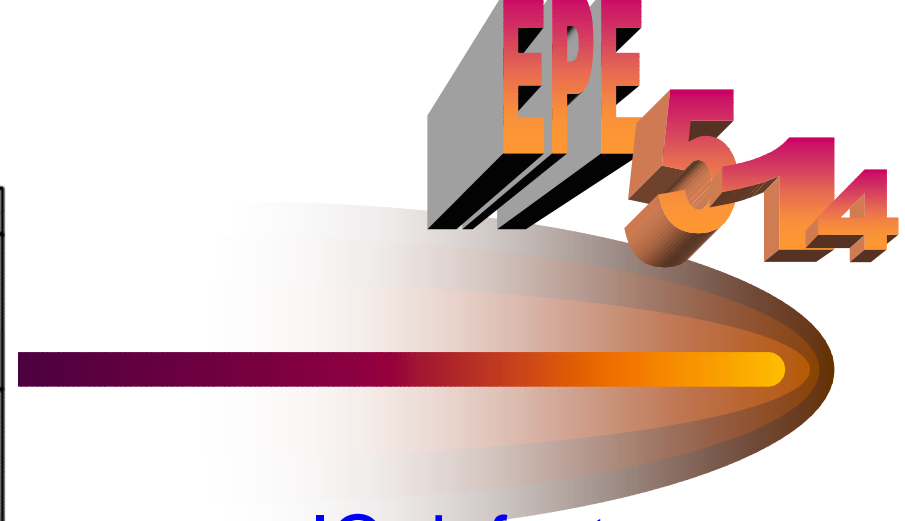
Circuit Side Scan	Non-Circuit Side Scan
Type I Delamination: Encapsulant/Die Surface

Type II Delamination: Die Attach Region

Type III Delamination: Encapsulant/Substrate (Die Side)

Type IV Delamination: Substrate/Encapsulant (Backside)

Type V Delamination: Encapsulant/Lead Interconnect

Type VI Delamination: Intra-laminate (Laminate Substrates Only)

Type VII Delamination: Heat Sink/Substrate

IC defect  
descriptions are  
now identified in  
**J-STD-035**  
(Acoustic Microscopy for  
NonHermetic Encapsulated  
Electronic Components)

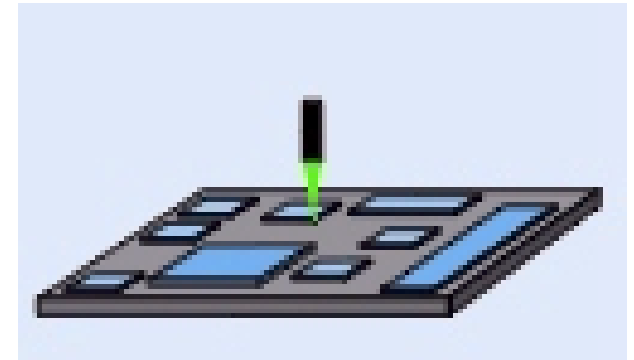
## A Failed Chip Scale Board Assembly is under investigation utilizing C-SAM inspection on components/board

- Identify component delaminations
- Identify board layer delaminations
- Make correlation to CSP package thermal cycle failures
  - CTE Mismatch
  - Package Proximity and Location on Board
  - Ball Bond Size and Location
